SkyStar Aircraft Corporation

SERVICE BULLETIN #21

SUBJECT: Flaperon Hinge Bearings **MANDATORY**

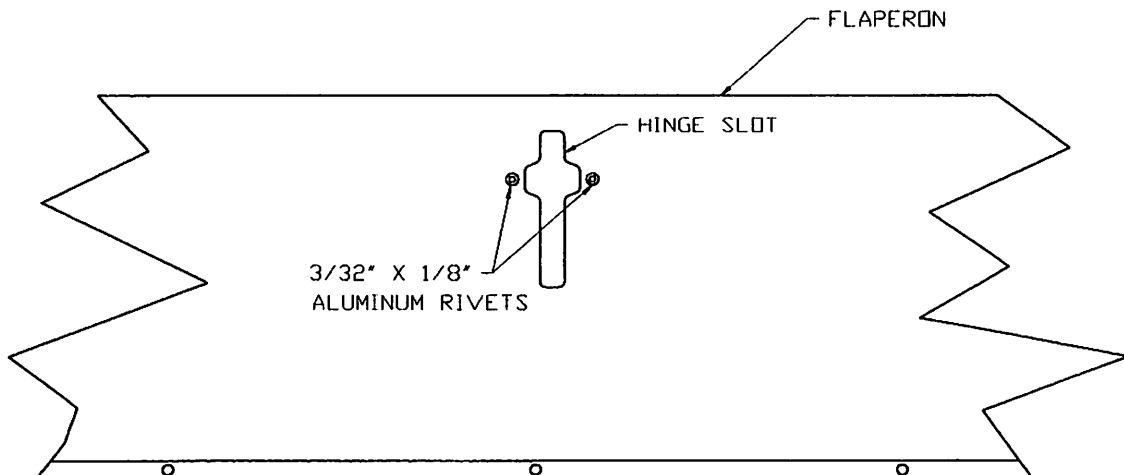
Several Kitfox Model I, II, & III owners have reported that some hinge bearings on the flaperon torque tube have slid to one side and out of the hinge bushing. Because of the potential problems that this could create, your safety makes compliance with this Service Bulletin **MANDATORY**.

INSTRUCTIONS: Make sure the bearing is centered into the hinge bushing. Per the drawing below, drill and rivet two $3/32$ "x $1/8$ " Alum. rivets through the skin and into the flaperon torque tube $1/4$ " out board of each hinge opening. Creating these "stops" will hold the bearings in place.
