SkyStar Aircraft Corporation

November 11, 1992

SERVICE BULLETIN #26

SUBJECT: LIFT STRUT ATTACH BRACKET TO FUSELAGE

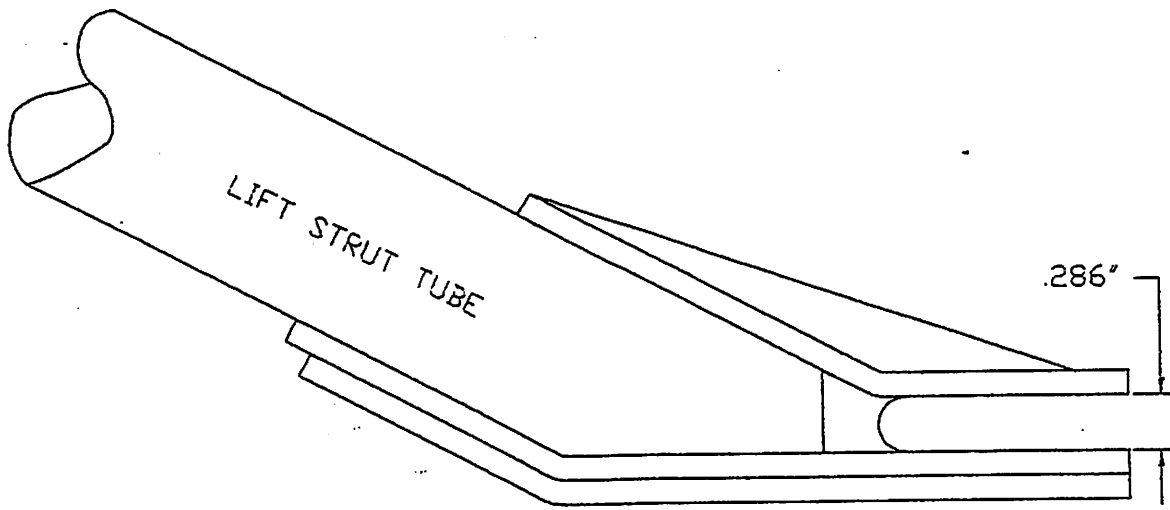
See diagram on Page 2.

It has come to our attention that some lift struts, shipped between Sept. 1 and Oct. 16, 1992, have fuselage mounting brackets that may have an improper gap between tabs, thus allowing the lift strut to fit too loose on the fuselage tab. This excess play between the fuselage mounting tab and the lift strut attach bracket, does not allow the castle nut to be secured on the AN6-11 bolt with a full safety pin hole showing on the bolt. There should be virtually no play between the fuselage mounting tab and the lift strut bracket. The temptation would be to over torque the AN6-11 bolt, to lessen the gap, but this would result in permanent damage to the bolt.

The appropriate lift strut bracket gap, prior to paint or powder coating, should be 0.286". Measure the thickness of the lift strut mounting tab on the fuselage and compare it to the distance between the flanges of the lift strut bracket. Typically, the lift strut bracket gap should be no more than 0.01" wider than the thickness of the fuselage tab. There should be little, if any, play between the lift strut and fuselage when installed correctly.

Using the typical, hardware store variety 3/8" fine thread cap bolt, matching washer and nut, as a torquing lever, tighten the bolt and nut down until the gap on the lift strut bracket is approximately 0.02" less than the required distance, allowing for some "spring back". This should close the gap to the required distance and allow adequate securement of the castle nut on the bolt. You may wish to repeat this procedure in small increments until a good fit is established.

As a safety factor, please discard these over torqued bolts and nuts. These bolts are not A/C quality. If you use AN, MS or NAS bolts for this adjustment, please discard them also because the adjustment will require a higher torque value than allowed for this hardware.
