SkyStar Aircraft Corporation

SERVICE BULLETIN: #28

SERVICE BULLETIN: RUDDER PEDAL GUIDE PULLEY SAFETY TAB

TO: EARLY MODEL IV CONTROL SYSTEMS

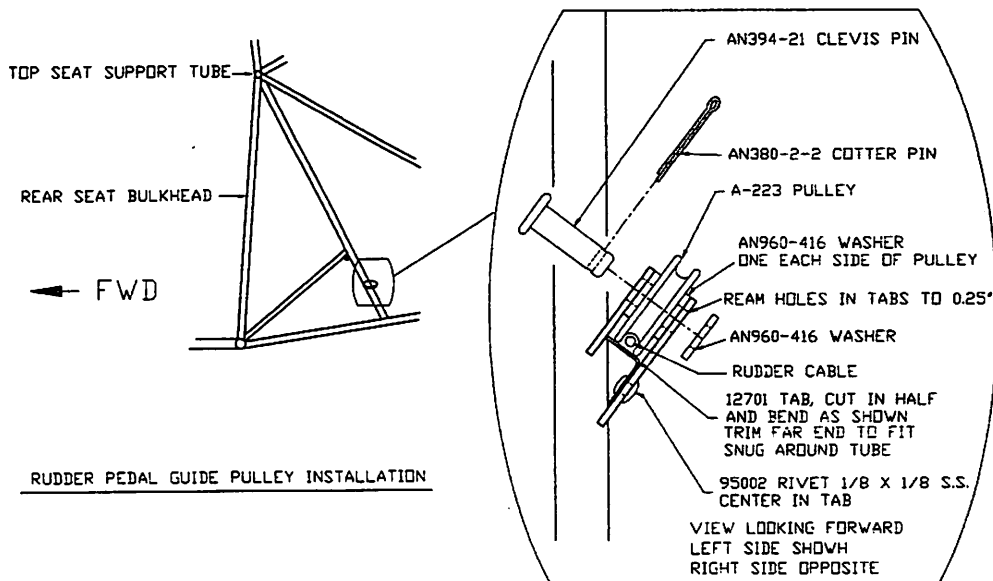
The original design of the Model IV control system and retro-fit control system, did not provide for a safety tab to keep the rudder cable from accidentally slipping out of the guide pulley. Without this safety tab, the rudder cable can slip out of the pulley valley and get caught between the pulley and the mounting tab. This is especially true when the rudder is manually manipulated, such as in pre-flighting, because the rudder cable is routed on the bottom side of the guide pulley. If the rudder cable is allowed to get enough slack in it, it is possible for the cable to come out of the pulley and get lodged between tab and pulley.

The #12701 Tab, is fabricated from thin aluminum material and riveted into place on the longer, pulley mounting tab, with one 1/8" X 1/8" stainless steel rivet. Per the diagram below, fabricate a #12701 Tab from the enclosed material and attach it to the pulley mounting tab in accordance with standard drilling, deburring, and riveting practices.
