SERVICE BULLETIN #30

SUBJECT: RETRACTABLE FLOAT MAIN GEAR MECHANISM - MANDATORY

TO: ALL KITFOX AIRCRAFT OWNERS WHO OPERATE RETRACTABLE FLOATS, 1100 series, Serial No.s 01L0492 through 44L0493.

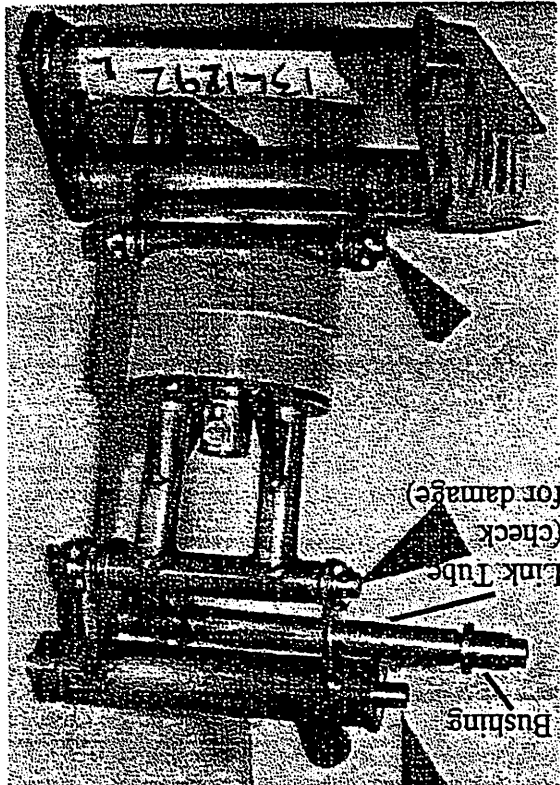
# FRONT VIEW OF MAIN LANDING GEAR

It has come to our attention that it is possible to damage the retraction mechanism during the rigging of the floats. The problem has only affected the left float mechanism at this time. Two situations have occurred during the initial rigging of the floats and to date there have been no failures arising from flight operations with the floats. This situation arises when the left float gear retraction cables are set to 30 pounds tension and then the right float right float gear retraction cables are adjusted next in sequence to 30 pounds tension. If the gear retract cables are rigged such that the left float gear reaches it's down and locked position prior to the right float gear reaching it's down and locked position, damage to the left float gear retraction mechanism is likely. The damage can occur when the left float gear is down and locked, but additional movement of the johnson bar is necessary to move the right float gear to the down and locked position. This additional movement of the johnson bar will indeed move the right gear to it's down and locked position, but it will also pull the cables attached to the left gear. The left gear cannot be moved any farther because it is already down and locked. When this happens, the link tube (part of the retraction mechanism for the left float gear) is likely to be overstressed. Subsequent operation of the landing gear retract mechanism will no longer move the left gear fully to it's down and locked position.

All amphibious float owner/operators must check their gear retraction cable rigging per the attached instructions to make certain that the cables are rigged properly, and that the right and left gears reach their down and locked positions simultaneously. Both the right and the left link tubes (see attached drawing) must be inspected for evidence of bending or twisting. In addition, the main gear over center travel must be checked per the attached drawing to make certain that sufficient over center travel exists. The gear retraction cable rigging must be checked at 100hr intervals thereafter to insure that the cables have not gone out of rig.

1. Support the floats on blocks.
2. Remove the main wheel assembly through the center opening in the float.
3. Note: place a straight edge so it runs from the center of the bottom shock pin holder and the center of the yoke tube as shown in drawing. Measure the distance from the straight edge to the center of the top shock pin. If necessary, the stop may be removed and shortened by grinding to gain sufficient over center movement. Refer to Fig. "A" to determine where to grind. Ensure over center is 1/8" to 3/16". See Fig. 1.
