AEROCRAFT
COMPANY

SERVICE BULLETIN #4

SUBJECT: FE-30 ELEVATOR WELDMENT

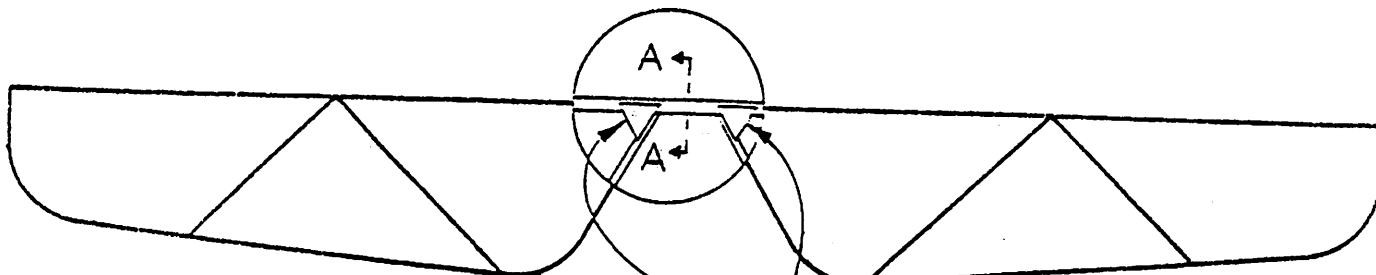
Recently, one builder who has flown his Model 1 KITFOX about 400 hours noticed a crack on the elevator weldment. The crack developed on the spar of the FE-30 at the inboard junction of the trailing edge on the pilot side.

We have designed gussets that need to be welded to the top and bottom of this spar-trailing edge juncture on both sides of the elevator control horn. We strongly recommend you do this as soon as possible.

INSTALL GUSSETS HERE,
TOP & BOTTOM OF
ELEVATOR WELDMENT
