SERVICE BULLETIN #55

DATE: December 01, 2001
SUBJECT: Nose Gear Strut
APPLICABILITY: All Series 5 (Vixen, Voyager) Tricycle Gear Aircraft
COMPLIANCE: Pre-flight
FROM: SkyStar Aircraft Engineering

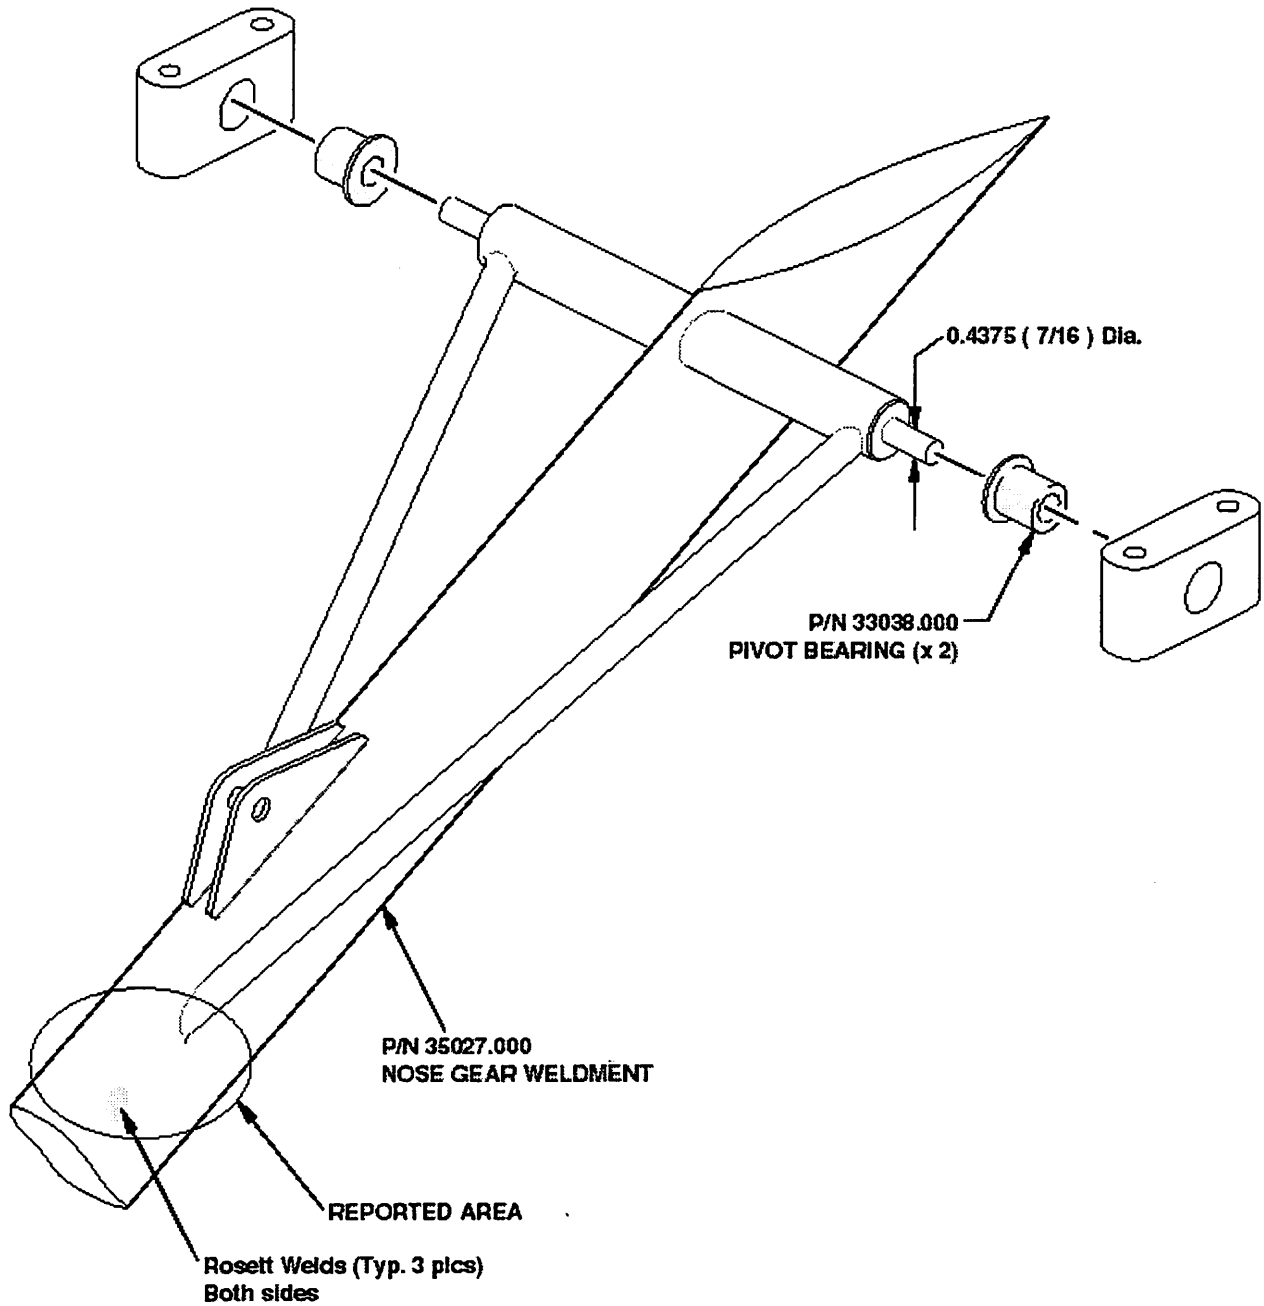
Figure 1

We have received reports of cracks developing forward of the rod end attach point where the support tubes are welded to the main nose landing gear strut (figure 1). These cracks could be caused by heavy side loading, a strong shimmy, twisting motion from rough field operations, or a hard landing. Some of these have been missed during pre-flight inspections and have resulted in failure of the nose gear. The reports have been most common with aircraft supporting the heavier powerplants such as the Continental O-200, IO-240B, Lycoming O-235, and converted Subaru engines.

ACTION: Prior to every flight the nose gear assembly should be carefully inspected. Rock the nose gently to the left & right to help make cracks more visible. It may be difficult to see an incipient crack under powder coating or paint. **For a Full Inspection:** Remove the powder coating or paint in the affected area and apply a dye penetrant to assure that hair line cracks have not developed. If any suspected side loading or shimmy occurs the nose gear should be inspected immediately. With the development of the Series 6, a heavy duty nose gear strut was created for the use of a larger nose wheel. This strut was also used on some late Series 5 aircraft. The heavy duty strut will have six rosett welds, 3 on each side of the main strut that incorporates an internal reinforcement and should be easy to identify. Those choosing to upgrade before February 1st 2002 can save \$445.71. In some cases the pivot bearings will need to be replaced. The diameter of the pivot pin on the newer nose gear strut measures 0.4375 (7/16"). Measure the pivot pin on your current gear and if it measures other than 0.4375 you will need to replace the pivot bearings as well.
