AEROCRAFT
COMPANY

SERVICE BULLETIN #9A

SUBJECT: Flaperon hanger rib
TO: KITFOX MODEL I, II, III owners in the United Kingdom - **MANDATORY**
FROM: Denney Aircraft Company

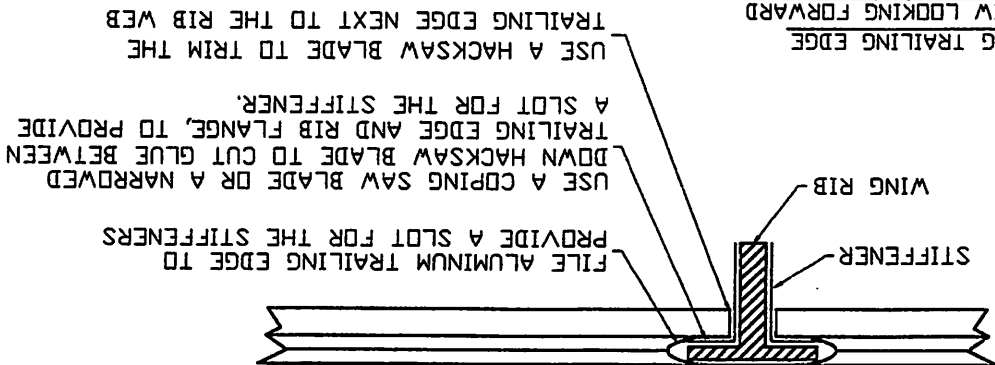
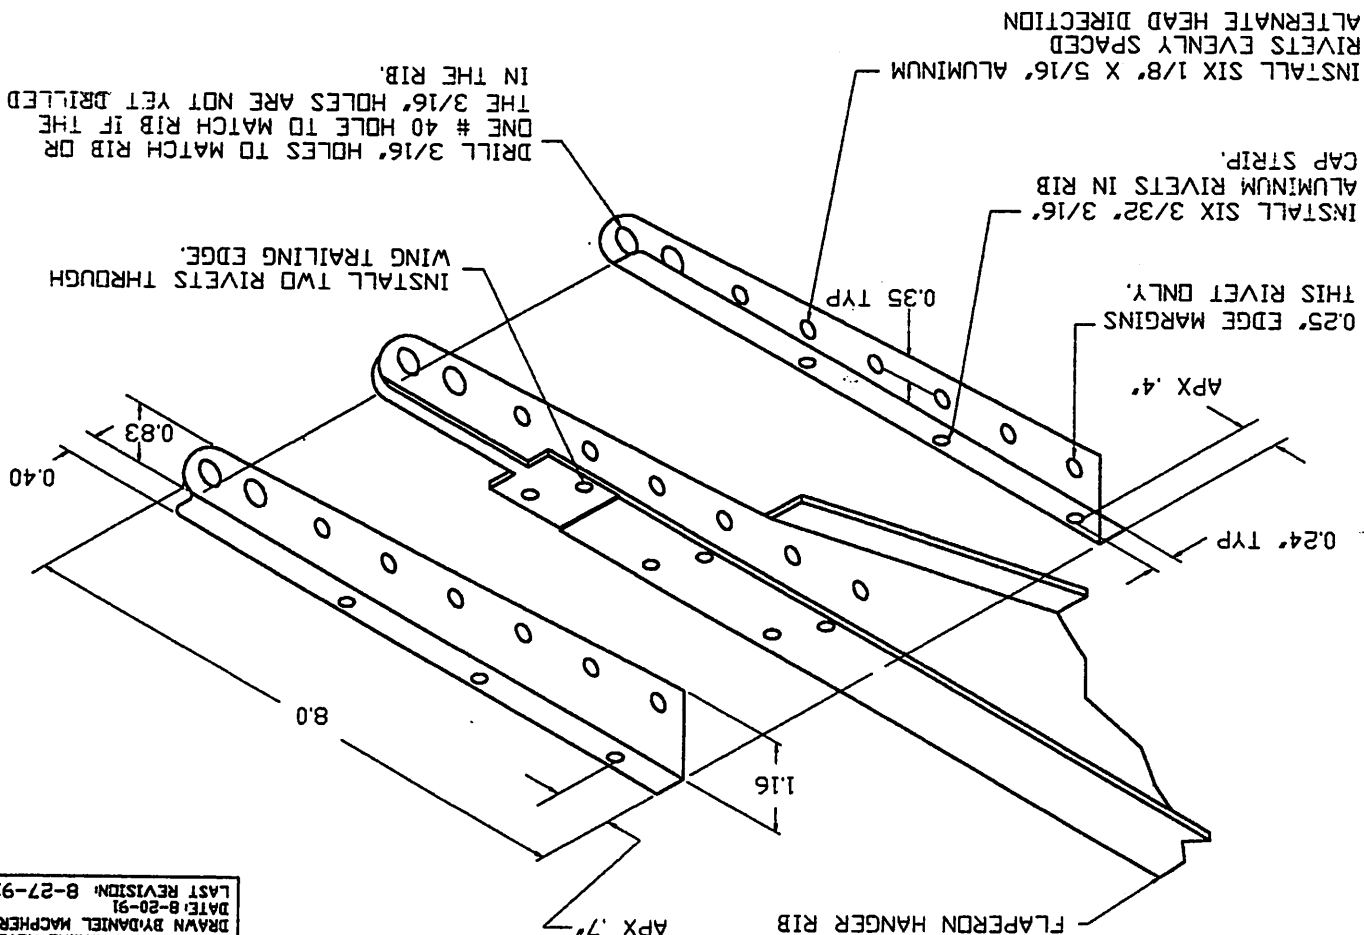
Attached Drawing D28002 Wing Rib Reinforcement

There have been two cases of Kitfox flaperon hanger rib failure documented in the United Kingdom. In both cases the failure appeared to be from side load overstress. Both aircraft had been in recent prior ground accidents. One was in an automobile accident while being transported on a trailer. The other mishap involved a nose-over upon landing. In both cases it is very likely that there were excessive side loads placed on the flaperon hangers which could have contributed to the subsequent failures. In the latter case the failure occurred on the ground during a period of engine operation at very low RPM's including engine operation on one cylinder, which caused the entire aircraft to shake violently. There was no personal injury to any persons in either case.

We have designed and tested reinforcements for the flaperon hanger ribs that can be readily fitted to Kitfox wings under construction or retro fitted to wings already completed. These modified ribs will withstand up to 150 lbs side load each when in reality the load will most likely be spread over the 5 hanger ribs. FAR 23 requires a side load capability of 12G's and 24 G's normal to the plane of the control surface. The flaperon with the Denney Aircraft mass balance weighs 7 pounds so you can see that it will withstand a side load of over 21 G's with the modification. We also tested standard un-modified ribs and they withstood 90 lbs of side load (12G's). In essence they met the Part 23 requirement for side loads without the reinforcement.

To meet the requirements of FAR 23 for in-plane loads of 24 G's the reinforcement must be installed on the two outboard ribs. (This assumes you have positioned your Denney Aircraft Co supplied mass-balance in the prescribed position near the outboard end of the flaperon). You should also install the reinforcement on each inboard rib to compensate for slack in the bearing or failure of the fuselage/turtledeck support bearing. If you desire to reinforce all ten flaperon hanger ribs that is ok but not necessary UNLESS you have installed the rod type mass-balance inserted in the leading edge of the flaperon as some have done in the U.K. If you have used the rod-type mass balance method then you should reinforce all 10 flaperon hanger ribs.

The reinforcements consist of left and right .025" 2024-3 aluminum angles riveted to each side of each flaperon hanger rib end. Each angle is 8 inches long and tapers from a depth of 1.2 inches to .8 inches with a flange of .4 inch. This flange fits flush against the bottom of the rib capstrip. The reinforcement angles are fastened to the tail of each hanger rib with 6 each 1/8 inch x 5/16 inch long blind "POP" rivets. Each aluminum angle is also riveted to the rib capstrip with 3 each 3/32 inch x 3/16 inch rivets. The builder will have to round the ends of each reinforcement angle to match the rib. He can at his option apply FSA-2 structural adhesive or the equivalent to the mating surfaces for increased joint strength. If this is done the reinforcement angle should be cleaned with acetone or MEK and rough sanded with 100 grit sandpaper.

To retrofit the reinforcement strips to a wing that is already covered, you will have to slit the fabric from the trailing edge about 8 inches forward along the centerline of the bottom of the hanger rib. Slit the fabric along the trailing edge about 2 inches on each side of the rib. Then you can pull the flap of fabric back away from the rib so you can drill rivet holes and install the reinforcement angles.

To repair the fabric you will have to remove the paint and dope down to bare fabric with Stits reducer, MEK, or other suitable solvent. Then use fabric tape to cover the slits and use Stits Poly-Tac, Poly-Brush, and Poly-Spray to attach and coat the tapes. Heat-shrink the patches and repaired areas to restore tautness to those areas. Repaint.
